CHATTANOOGA-HAMILTON COUNTY AIR POLLUTION CONTROL BUREAU

Report for the Amnicola Highway / Wisdom Street Investigation

Source: The Mueller Company

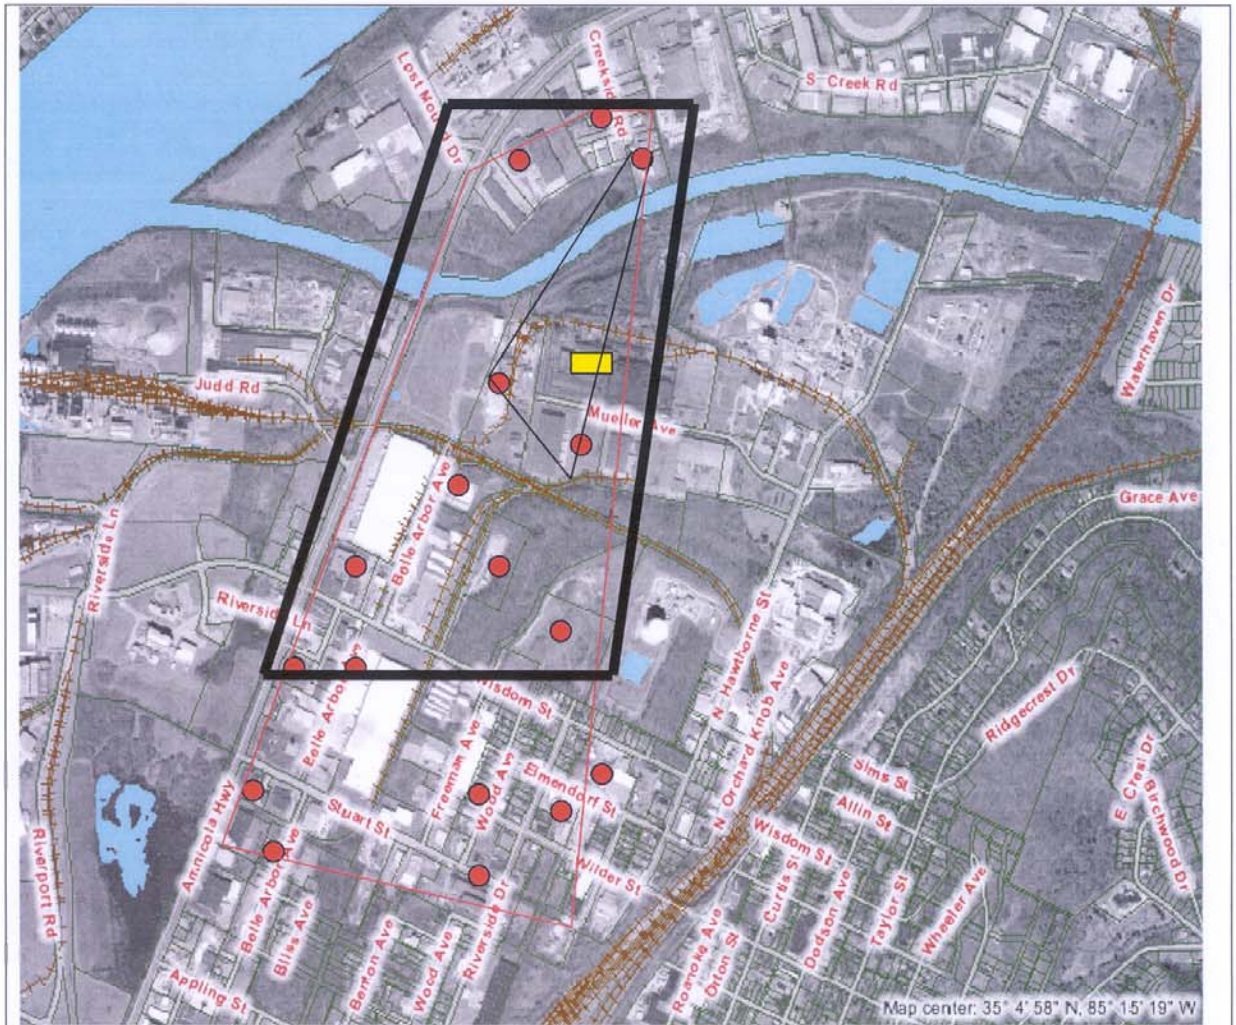
In the map below the area within the thin black lines are where the complainants stated that fallout/rust spots had been a problem for years. The area within the red lines are areas affected, according to the complainants, after the August 2006. The dark black area is where the most damage was found. Complaints were received outside of the identified area but those proved **not to be** consistent with the identified areas.

● = Confirmed locations of affected vehicles ■ = The Mueller Company
